**Video Image Detection  
COMPARATIVE TESTING OF  
VARIOUS DETECTION TECHNOLOGIES**

SEC Project No. 1810001-000

Schirmer Engineering Corporation

February 11, 2010

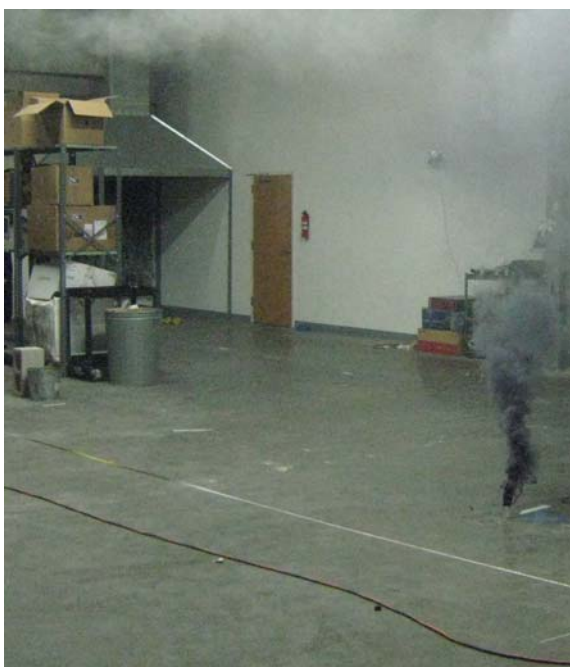
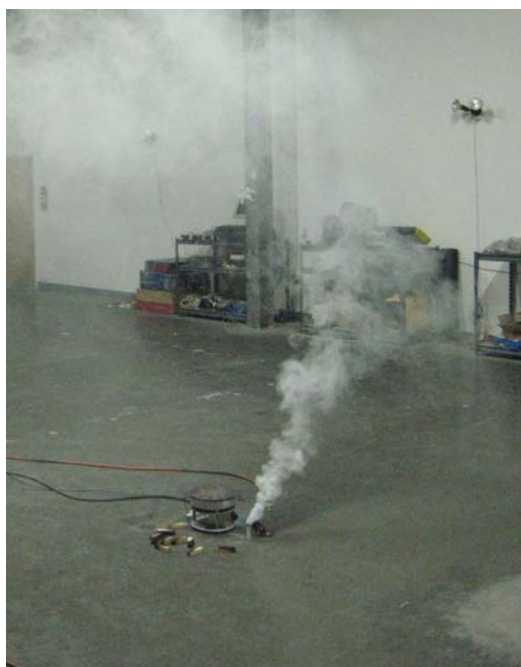
Figure 7: Smoke Emitters

The black and white smoke emitters have a similar consistency to those used in the BFPSA report. The white smoke emitter produces smoke for approximately 3 minutes with a total smoke volume of 1,200 ft<sup>3</sup>. The black smoke emitter produces smoke for approximately 4 minutes with a total smoke volume of 1,200 ft<sup>3</sup>. Both smoke emitters are lit using a butane lighter and the smoke emitters are permitted to burn until self-extinguishment. Figure 7 shows both the black and white smoke emitters used in the test series.

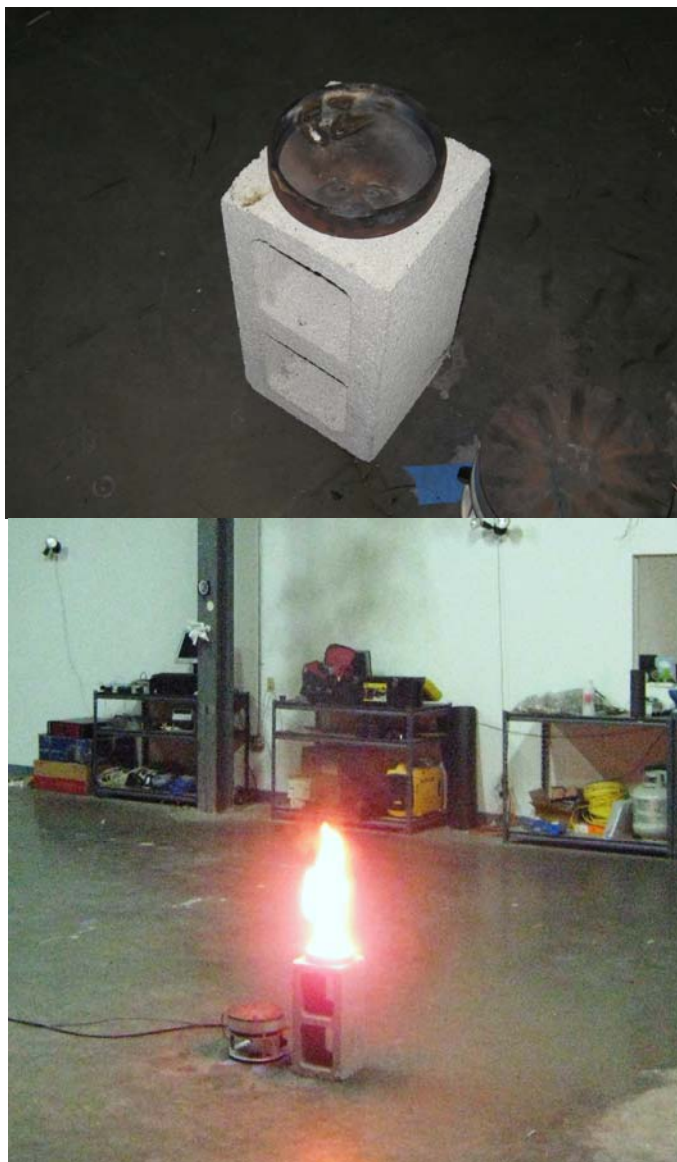
Figure 8: UL 268 Flammable Liquids Fire

The flammable liquids fire consisted of a mixture of fifty percent toluene and fifty percent heptane in a round metal receptacle. The container consists of 0.025 inch stainless steel, with a diameter of 6 ¼ inches and a depth of 1 ¼ inches. The liquid mixture was lit with a Butane lighter and permitted to burn until self extinguished. Figure 8 shows the receptacle for the flammable liquids fire and resulting flame.

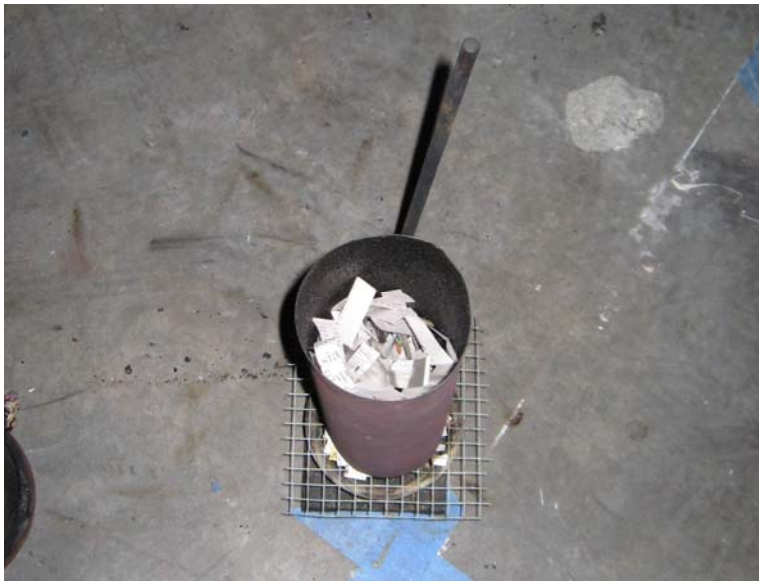
Figure 12: Aerial View of UL 268 Tamped Paper

The UL 268 tamped paper fire consists of shredded newspaper in strips  $\frac{1}{4}$  to  $\frac{3}{8}$  inch wide and 1-4 inches long. Approximately 3 ounces of newspaper strips are placed in a large sheet metal container with a height of 12 inches. The paper is tamped with a rod until the newspaper strips are approximately 4 inches below the container opening. A hole with a 1 inch diameter is formed in the middle of the receptacle to prevent air circulation. The assembly is lit using a butane lighter and permitted to burn until extinguished. Figures 12 and 13 include pictures of the UL 268 tamped paper fire set-up.

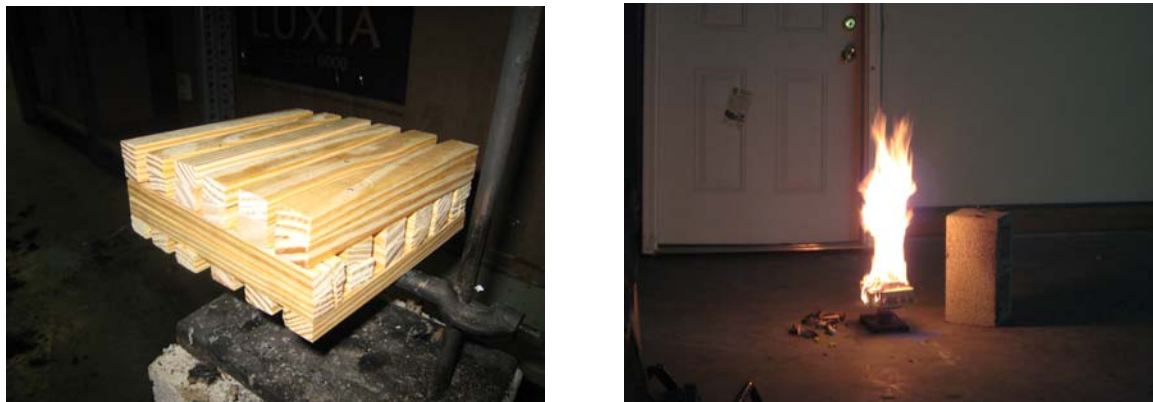
Figure 14: UL 268 Wood Crib Fire Configuration & Fire

The UL 268 wood crib fire used a wood crib with dimensions of 6 x 6 x 2½ inches. The wood crib was supported on a ring stand approximately 9 inches off of the test room floor. A container with 10 milliliters of rubbing alcohol was placed approximately 3½ inches below the center of the wood crib. The rubbing alcohol was first ignited which then allowed for ignition of the wood

crib. The test continued until the wood crib was extinguished. Figure 14 shows the UL 268 wood crib fire configuration and flaming mode.

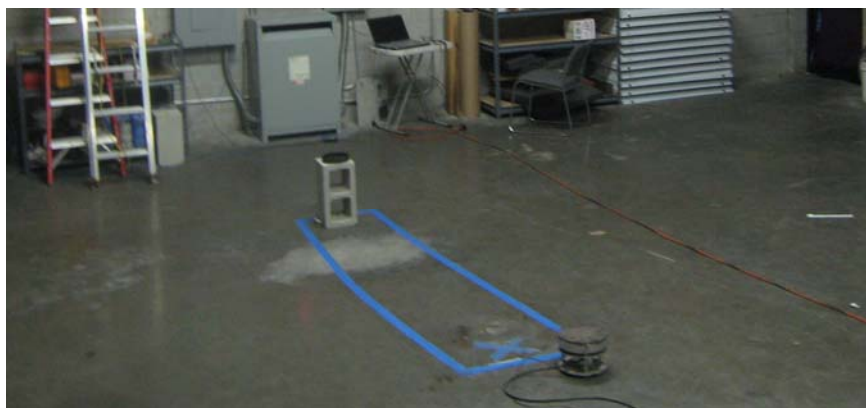
Figure 15: Location 1

Location 1 was a general open test location and located along the centerline of the room as indicated in the blue lines of Figure 15. Within the blue-lined area the exact fire/smoke source location was varied by moving the location to one of three spots within the blue-lined area during the test series.

The variations at Location 1 were performed in order to observe if there were any significant effects in detector responses due to locating the fire/smoke sources directly under the spot detectors verses directly under the ASD port. Some differences were observed but generally the results showed that the detector responses were reasonably consistent for any position within the blue-lined area (see Figure 15) marking Location 1.
